# **AEROPLANE AND ARMAMENT EXPERIMENTAL ESTABLISHMENT**

WYVERN S. MK.4 VW.684  
(PYTHON 3)

PRELIMINARY DIRECTIONAL HANDLING ASSESSMENT

A. & A.E.E. Ref: 5720, h/11/THJH  
M. O. S. Ref: 7/AoFt/5909/RDN1  
Period of Tests: September and October 1952

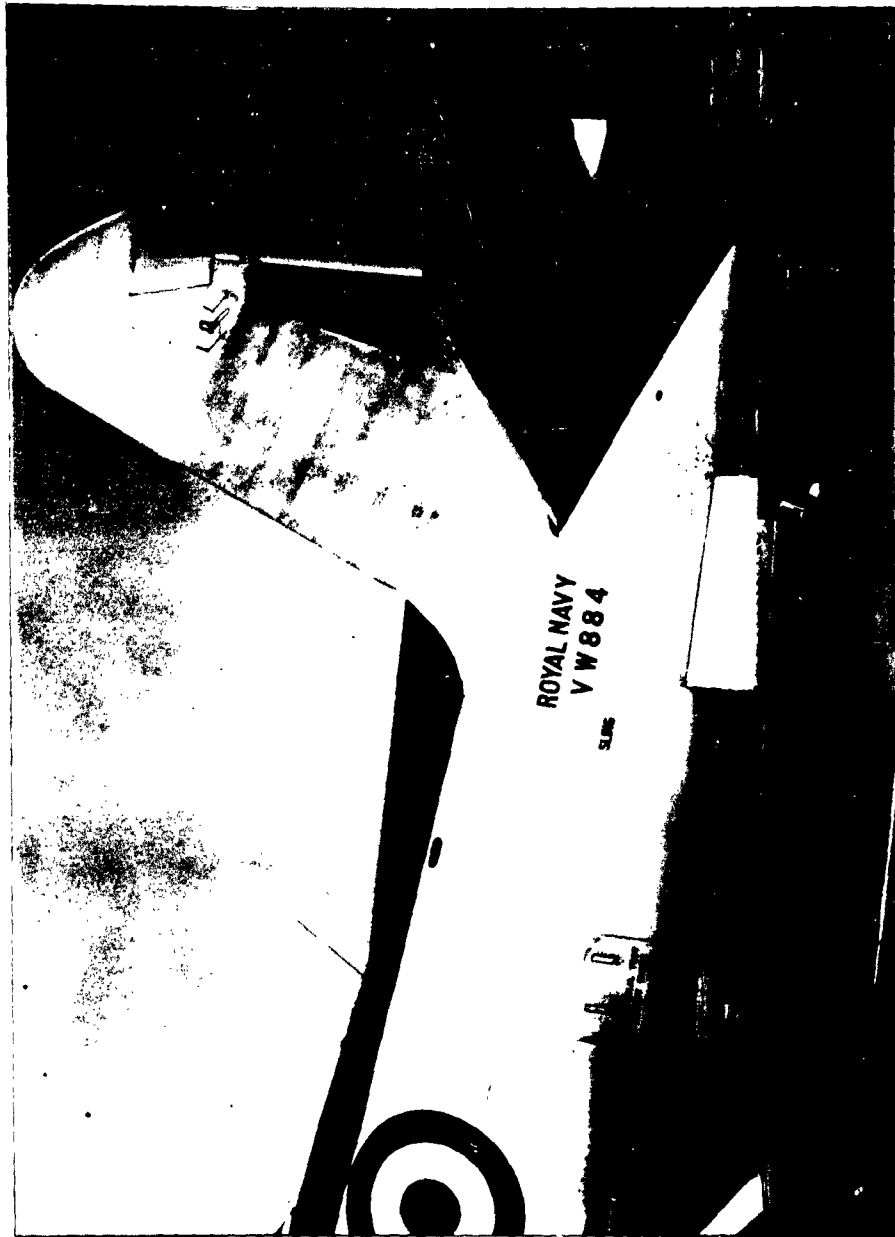
FIG. 1.

Stage 5 tests. As stage 4, with the addition of a dorsal extension to the fin. (see Photograph).

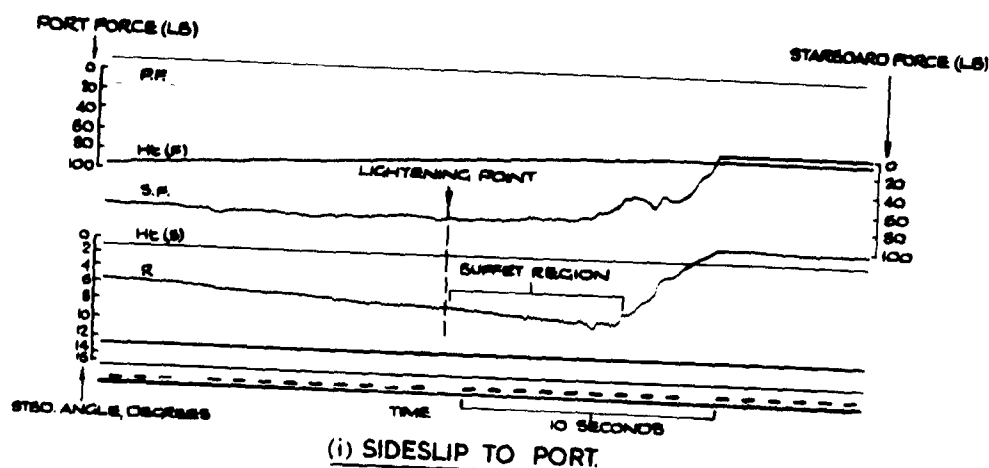
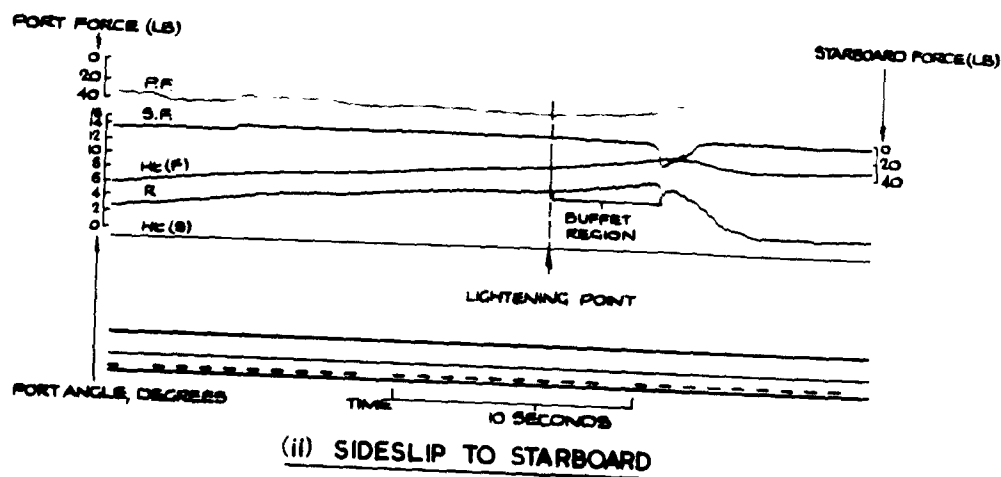
**FIG. 2**

The results are summarised in the following table. Foot forces quoted are nett values (i.e. port minus starboard or vice versa) from the Hussonot recordings, samples of which are given in Fig.2.

5	68 lb. at 6° lightening to 53 lb. at 8½° (12°). Test stopped here since rudder appeared to be moving over of its own accord.	48 lb. at 7° lightening to 26 lb. at 8½° (11°).	Trimmed as for Stage 1, 80 lb. Starboard foot force required at 435 kts. I.A.S.

In all the above tests, lightening of the rudder bar forces was accompanied by buffeting. During the dives, directional unsteadiness was observed as on previous Wyverns. The aircraft was difficult to fly in any turbulence without some sideslip, which would change sign erratically. Further there appeared to be slight bodily movement sideways in bumps or following slight rudder movement. This characteristic was not noticeably affected by the dorsal fin.

**SAMPLE HUSSENOT RECORDS OF STRAIGHT SIDESLIPS.  
DORSAL FIN FITTED.**

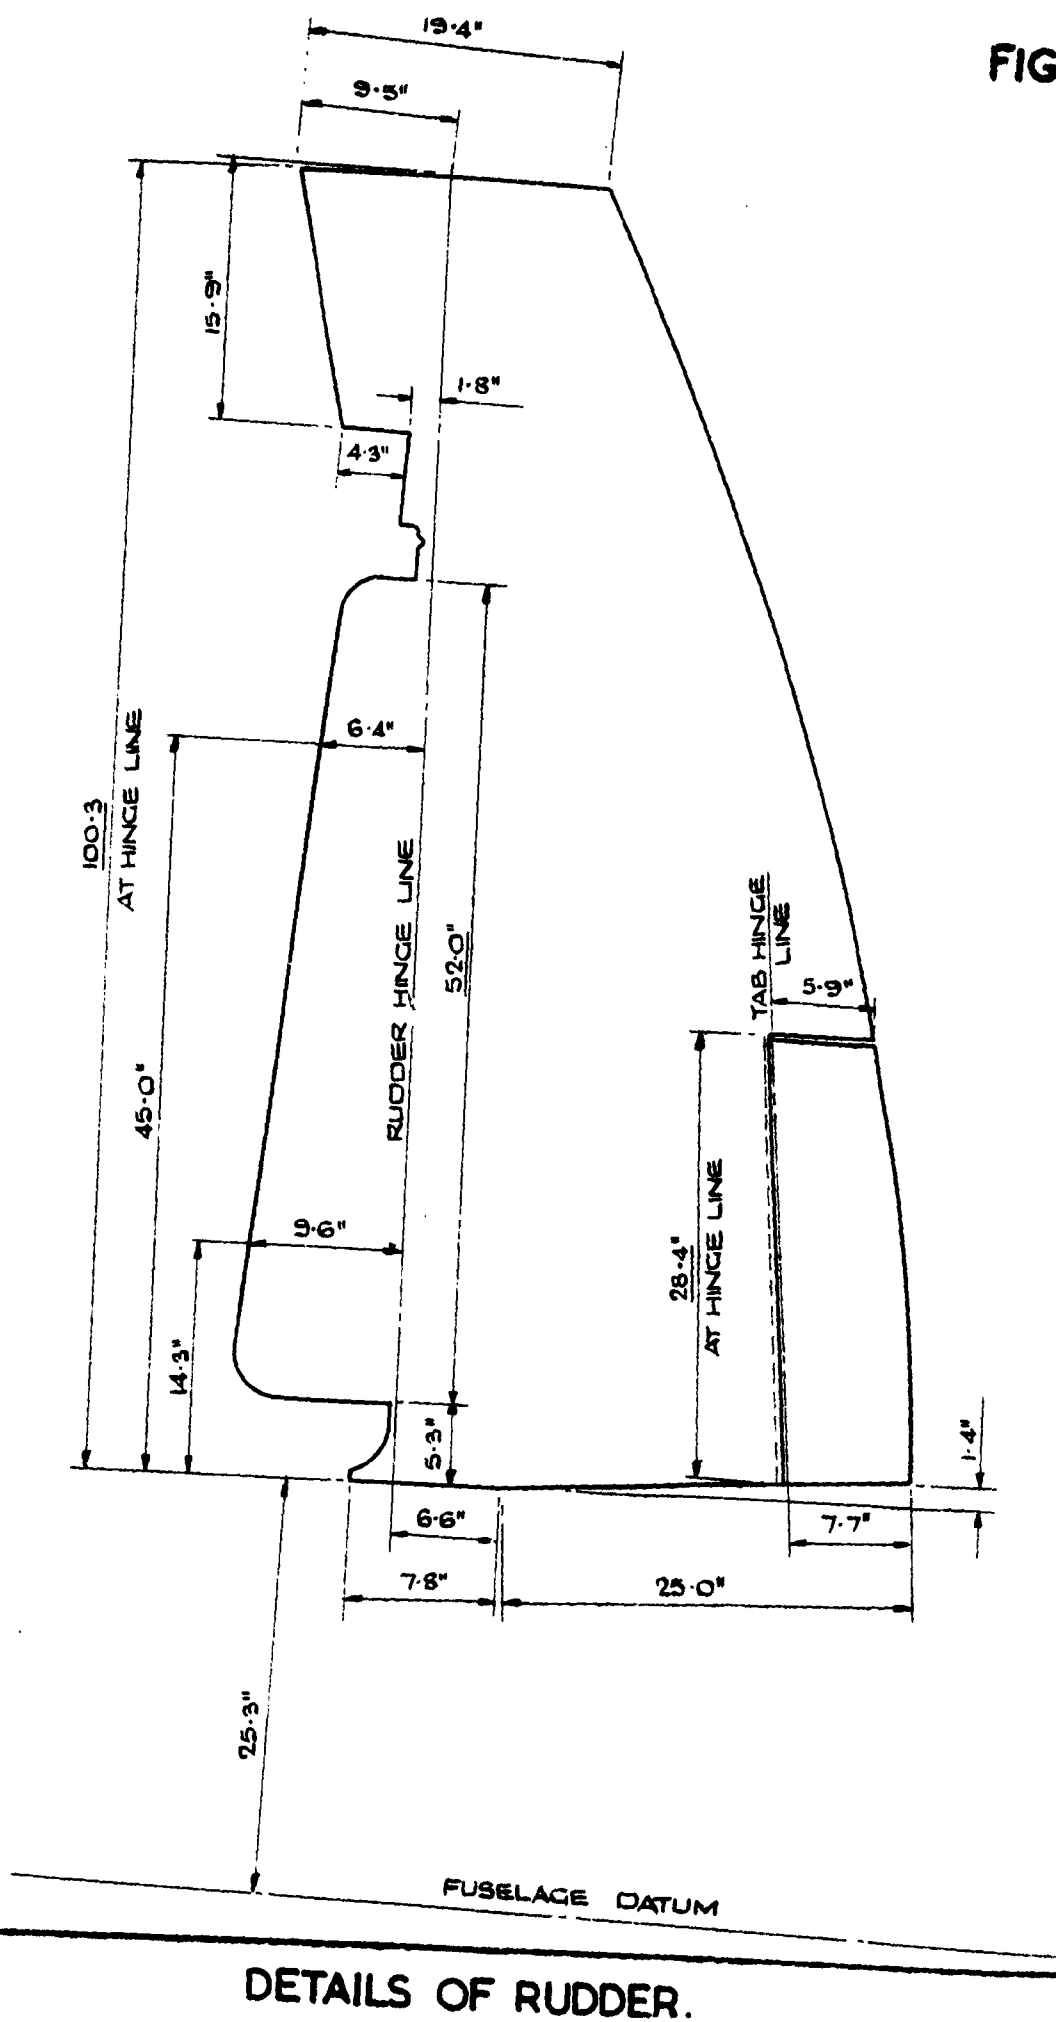
FIG. 3.

2.5 Rudder and fin details. A diagram of the rudder as originally fitted to VW. 884 is given in Fig.3.

The leading edge of the rudder above the top hinge was extended forward to form a 'horn balance'. The rest of the rudder leading edge, between the top and bottom hinges, was shrouded by rearward extensions of the fin skinning. The gap between the fin and the rudder nose was fully sealed by rubberised fabric.

Gross fin and rudder area	50.2 sq.ft.
Gross rudder area	17.1 sq.ft.
Rudder area aft of hinge line	13.3 sq.ft.
Horn balance area above top hinge and forward of hinge line	0.97 sq.ft.
Tab area	1.59 sq.ft.
Rudder travel	15° each way.

DETAILS OF RUDDER.
